From: White, Lisa
Sent: August 2, 2016 02:35 PM
To: Hewson, Kevin
Subject: FW: Wildhorse Update

See the below Wildhorse update as of August 2nd:

From: Singer, Steve
Sent: May 26, 2017 09:10 AM
To: Simonson, Lyle
Subject: FW: 2017 Building Performance survey- CBSA
Attachments: Building Performance ReviewDelBonita -2017 - CBSA Building.docx; Building Performance ReviewWildHorse -2017 - CBSA Building.docx

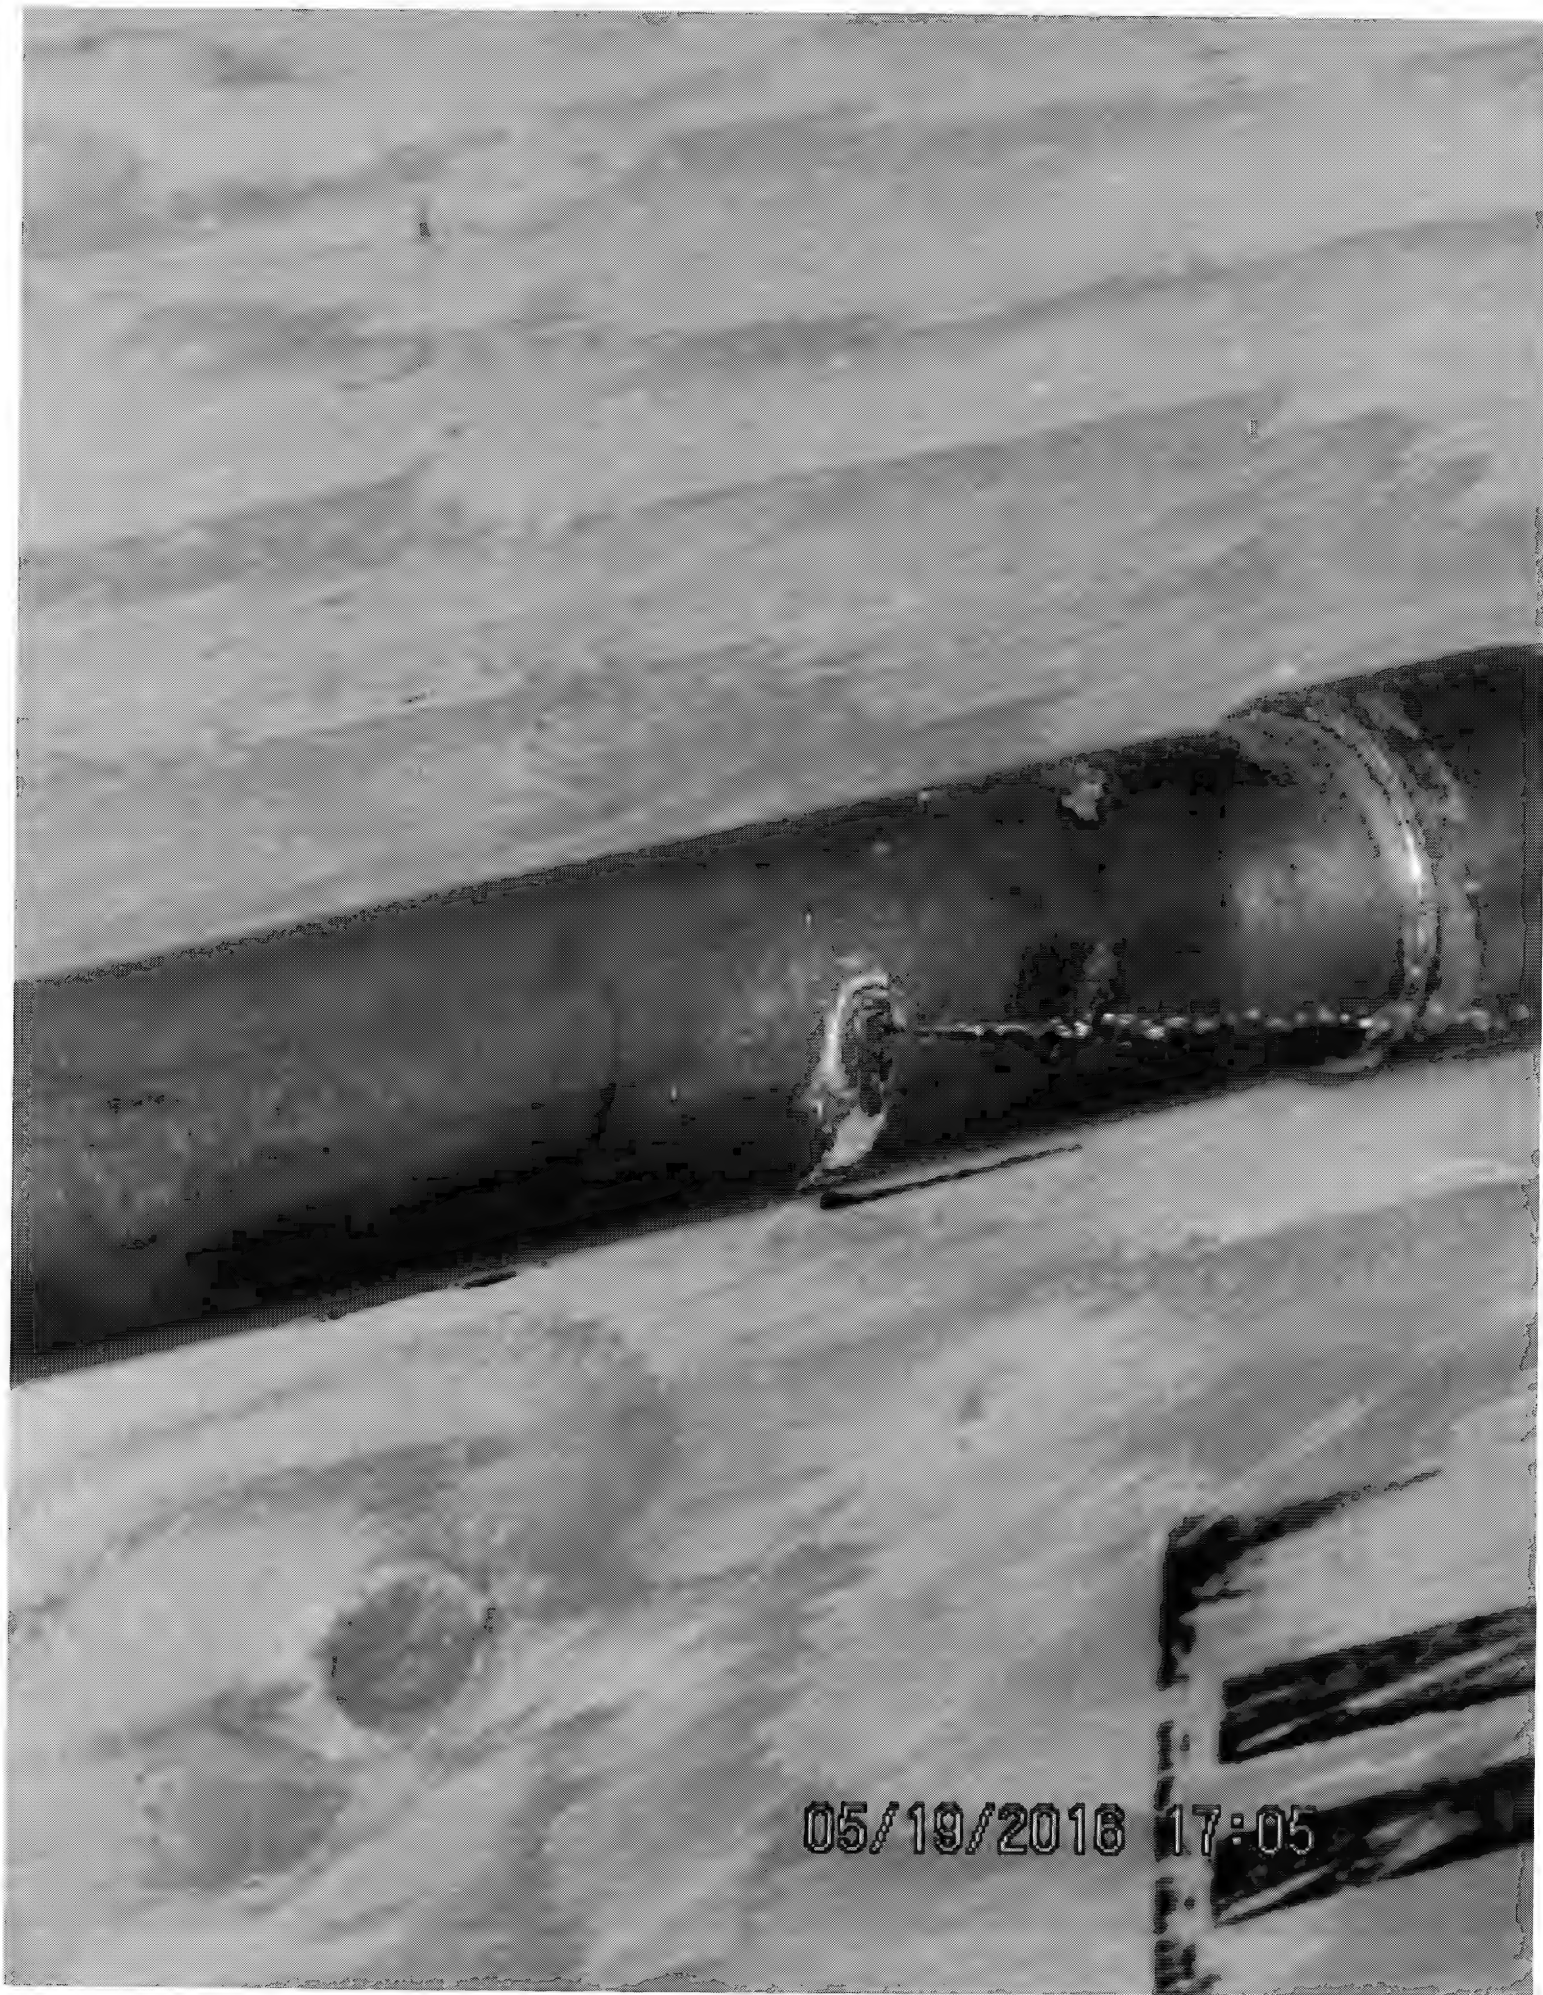
Fyi we have water leaking in the basement at WH. Brookfield had it set to action for June. We have called them to say it is urgent but nothing back as of yet.. Calling the plumber myself to see what can be done. We have a pin hole in the pipe and a fitting that seems cracked. On the plus side if it fills with water maybe it will float away.

Here are a couple more photos of the leak. The one is of the copper pipe that has a hole in it. The other photo is of a seal that we can feel also leaking. We believe that the hole in the pipe is causing most of the water. Brookfield was called and update as well

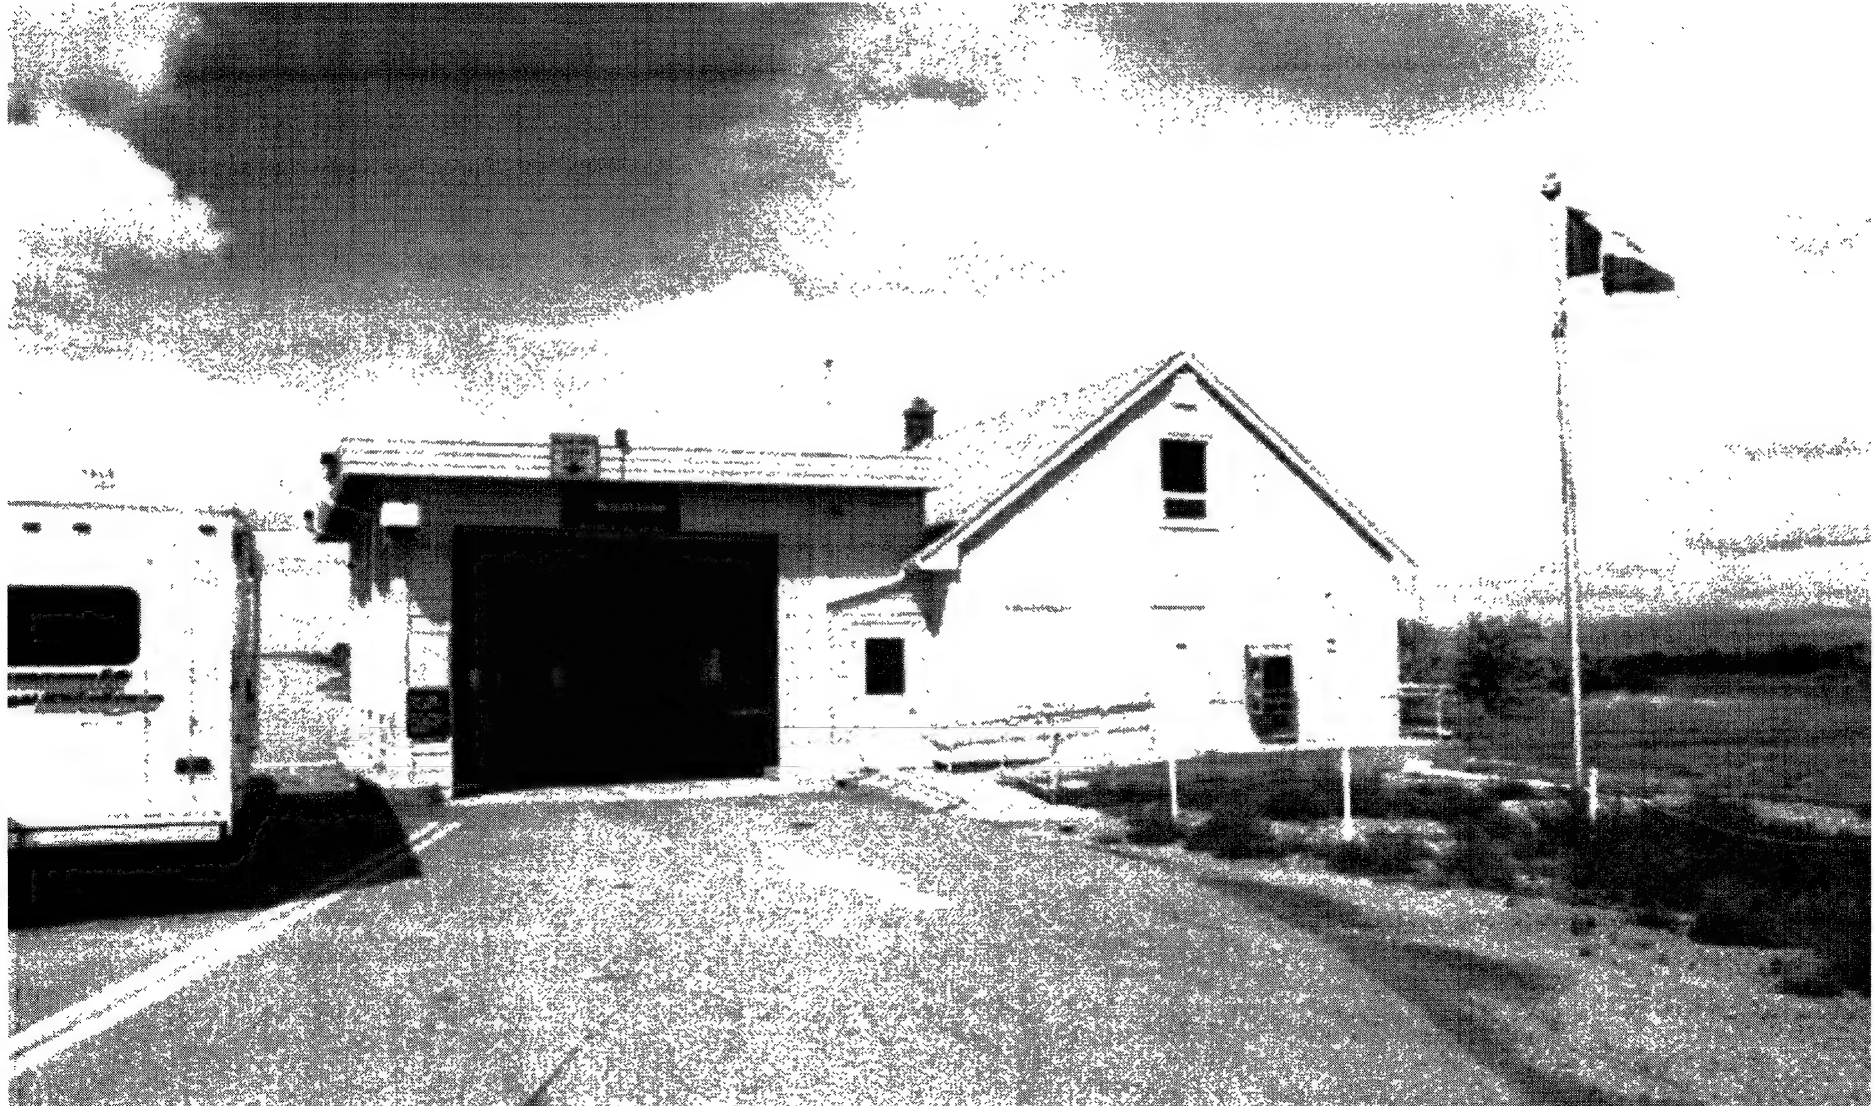
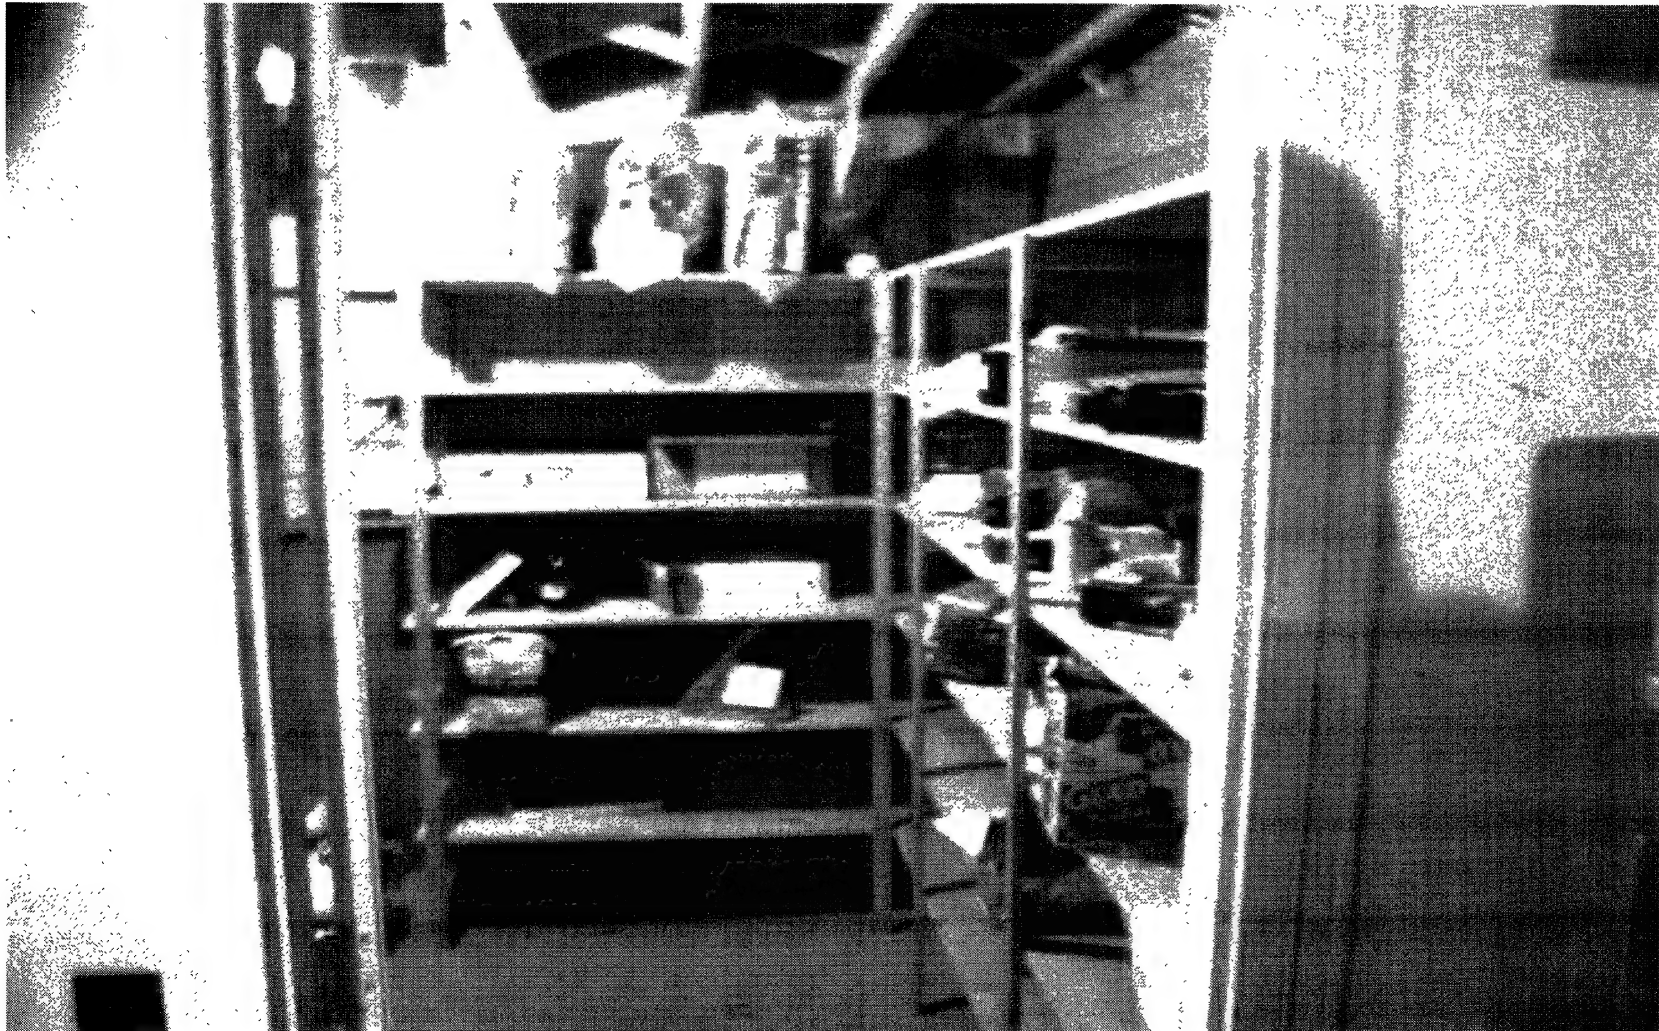
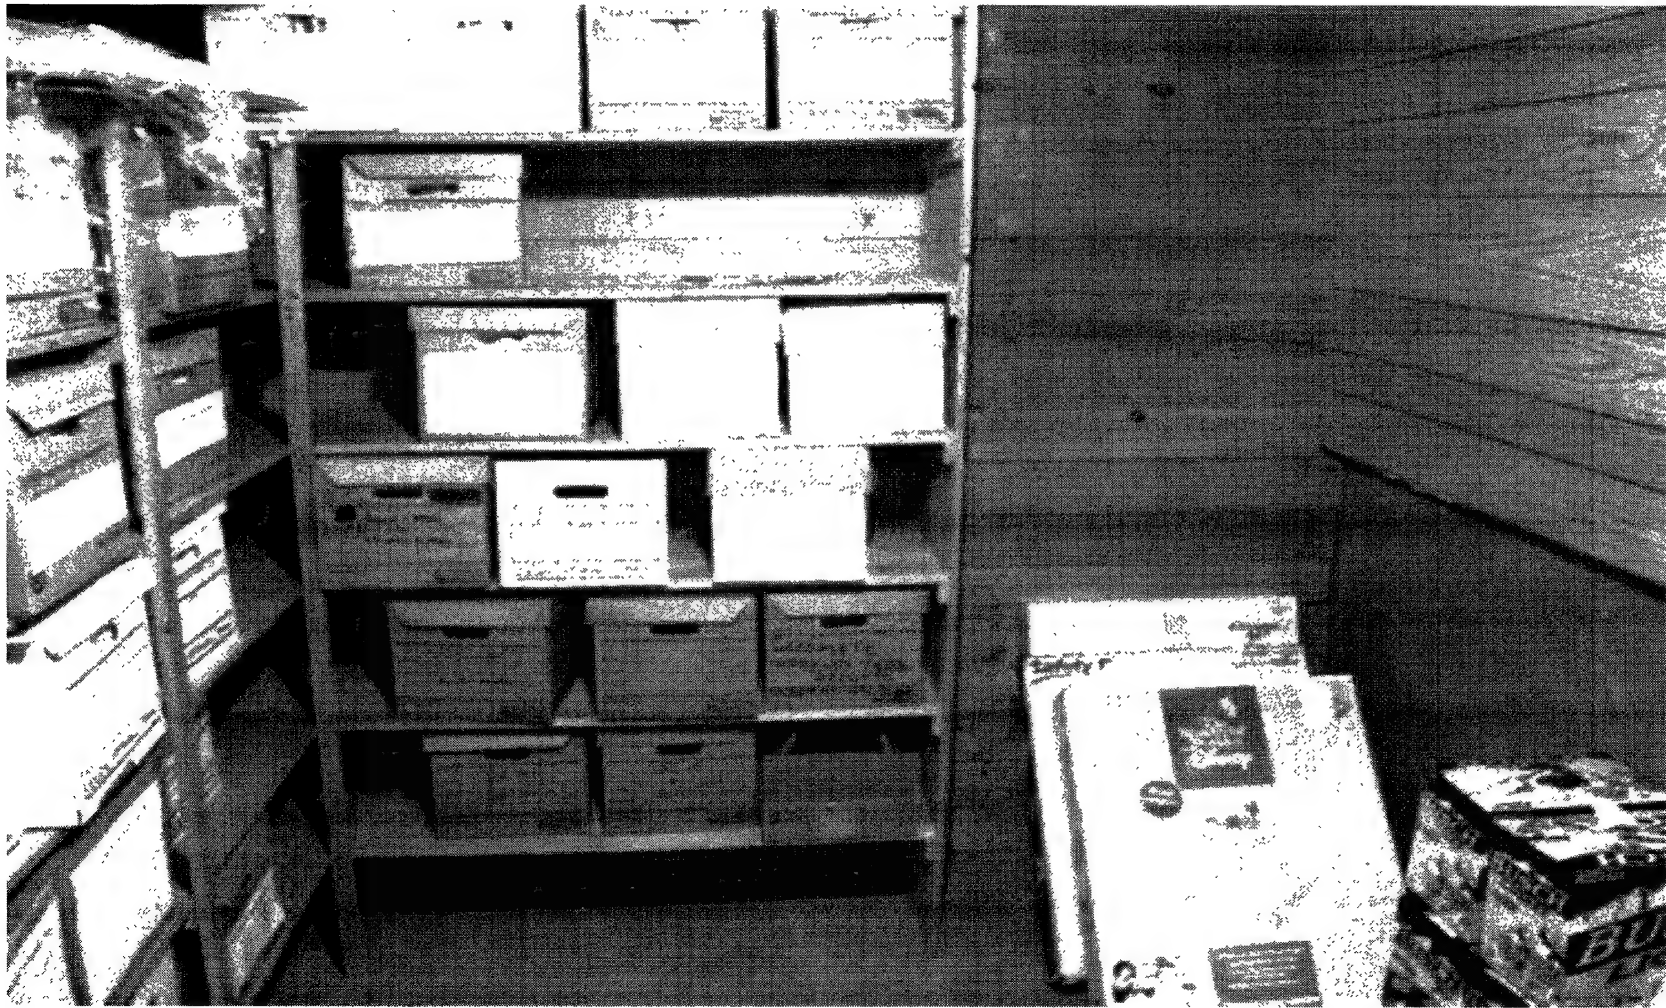
- Wild Horse has a room in the basement that functions as the Queen's warehouse.
- Two safes exist upstairs. One for Port assets and one for Seized/Held High risk goods. This could not be taken downstairs due to access issues.
- Port replacement list

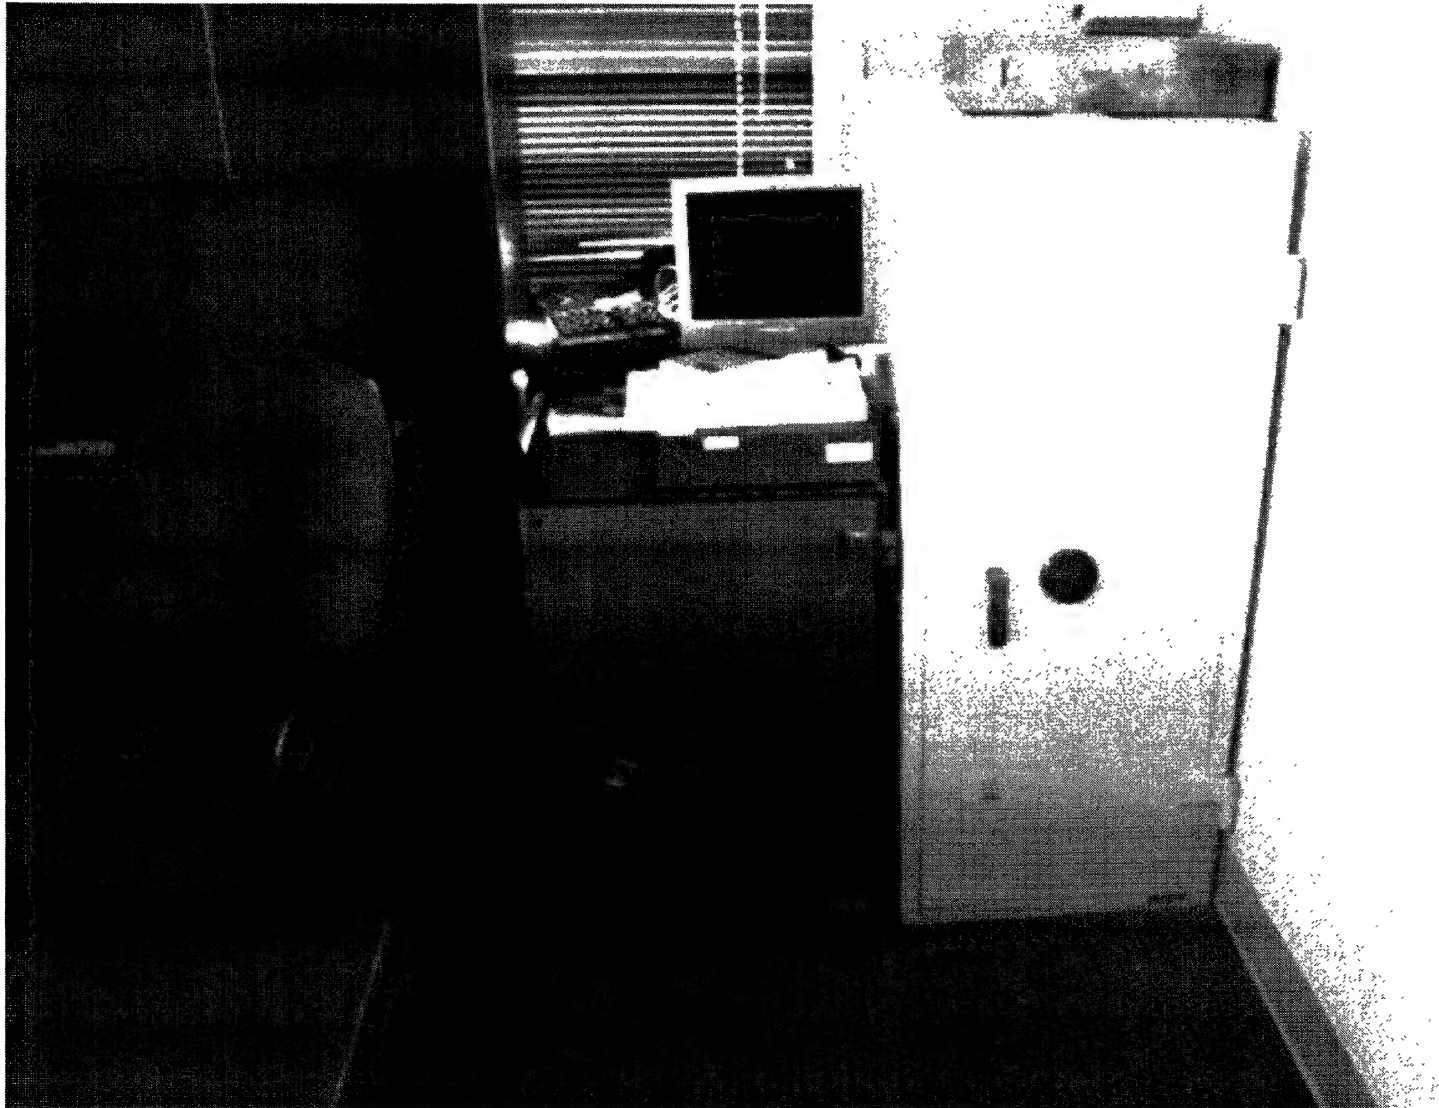
Safes Upstairs in Wild Horse

- Wild Horse is very remote. Police response time is approx 2 hours.
- Port replacement should consider extra security aspects for new building.
- No history of unauthorized access
